**SR 410 – Junction 241<sup>st</sup> / Mud Mountain Road (MP 22.17 to  
22.35) Buffer Mitigation Site  
C6282**

**2007 MONITORING REPORT**

**Wetland Assessment and Monitoring Program**

# SR 410 – Junction 241<sup>st</sup> / Mud Mountain Road (MP 22.17 to 22.35) (Boise Creek 2) Buffer Mitigation Site

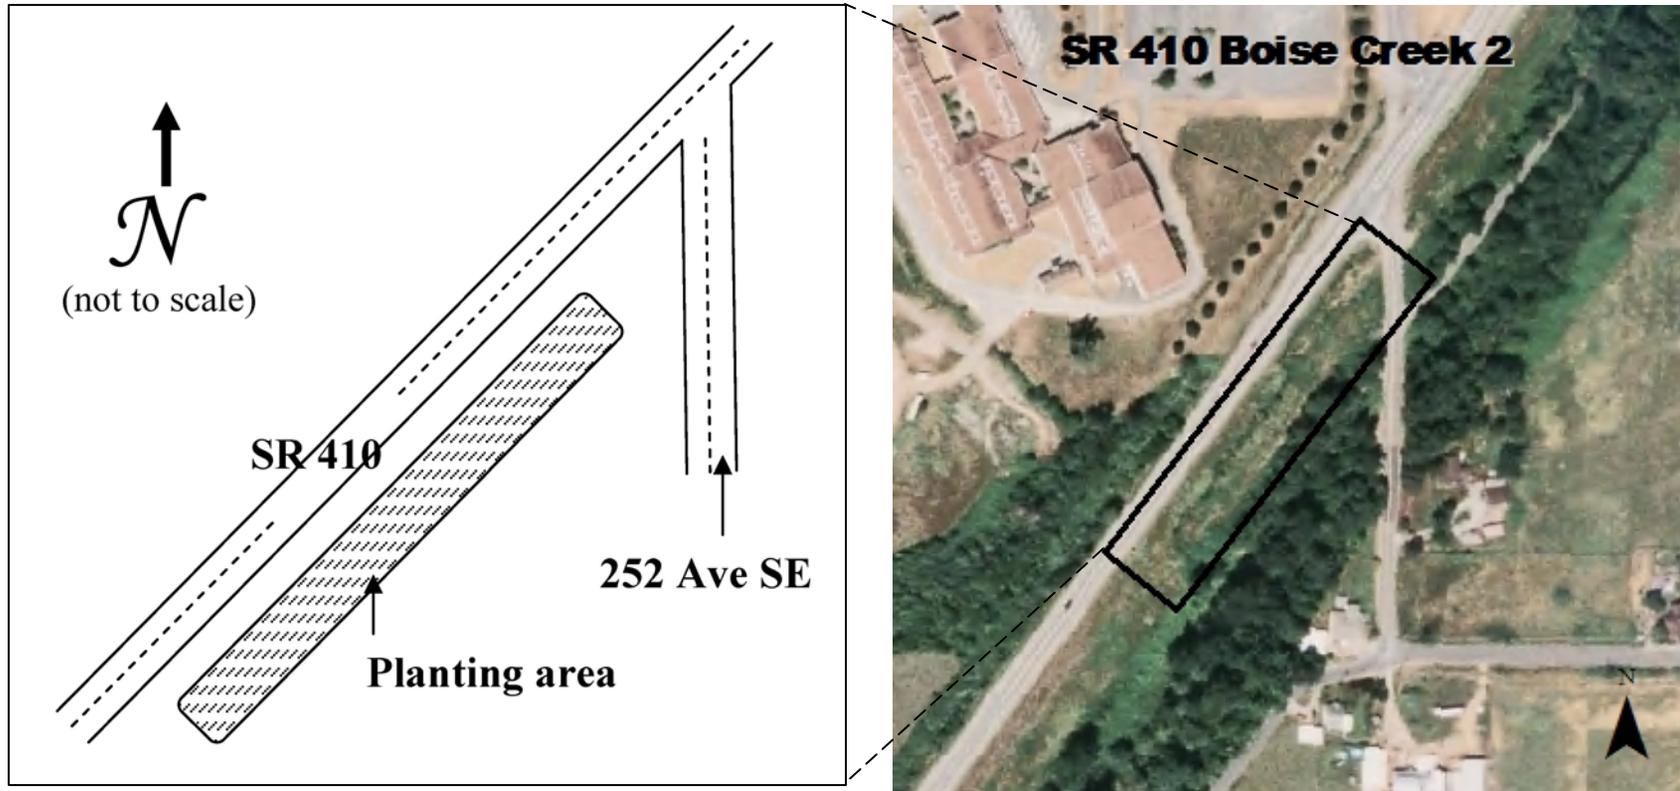
**Figure 1 Site Sketch**

This mitigation site (Figure 1) includes areas of stream and wetland buffer enhancement. This site was created to compensate for the loss of 1,055 square feet of King County class two wetland buffers due to road improvements along SR 410. The stream buffer is designed to provide mitigation for lost wetland buffer functions including water quality and wildlife habitat functions.

The SR 410 Boise Creek 2 Mitigation Site is comprised of an enhanced stream and wetland buffer.

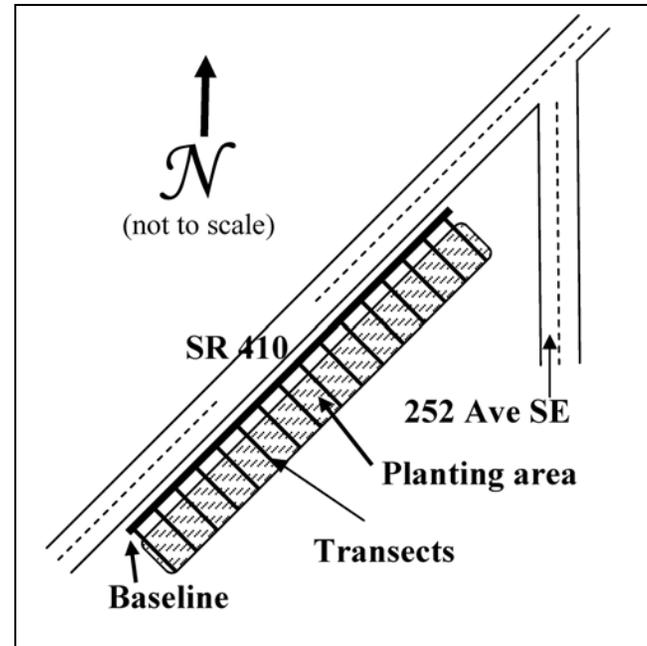
Figure 2 Site Sampling Design (2007)

To evaluate standards for vegetative cover, a baseline was established parallel to SR 410 (Figure 2). Twenty-seven sampling transects were randomly placed perpendicular to the baseline. The line intercept method was used to estimate woody cover (Success Standards 2 and 3), and the point intercept method was used to estimate invasive species cover (Success Standard 4).

To assess vegetation standards, a 55-meter baseline was established parallel to SR 410. Twenty-seven temporary sampling transects were placed perpendicular to the baseline using a systematic random sampling method (Figure 2). Aerial cover of woody species (Success Standards 2 and 3) was assessed using the line intercept method. Twenty-seven 3-meter line-segment sample units were randomly positioned along sampling transects across the site. The point intercept method was used to estimate aerial cover of invasive species (Success Standards 4). Twenty-seven randomly positioned 3-meter point-line sample units (20 points each) were placed along the sampling transects.

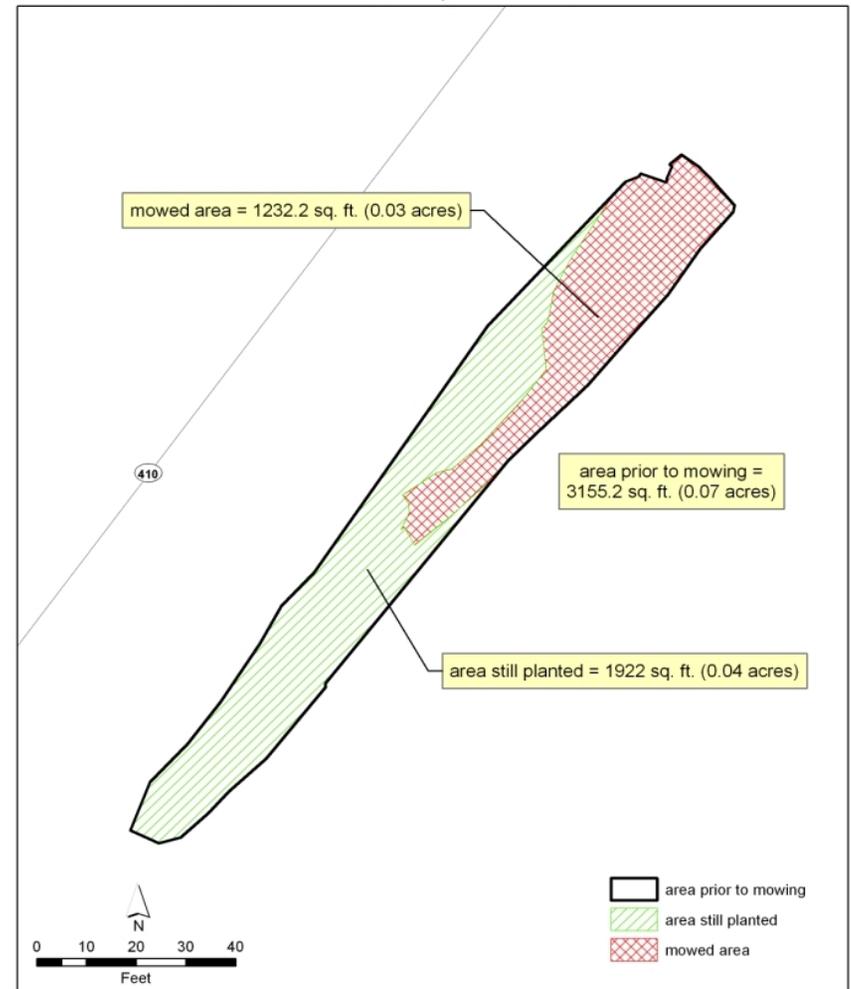
Figure 3

After monitoring was completed, it appears Tacoma Power inadvertently mowed a portion of the mitigation site. Mowing affected approximately 40 percent of the site, leaving just 1,922 of the original 3,155 square feet of mitigation intact (Figure 3). However, according to the mitigation report, only a minimum of 1,055 square feet is required to compensate for impacts to stream and wetland buffer. The remaining planted area (1,922 square feet) surpasses this threshold.

GIS map of planting area after mowing.

Prior to mowing, survival of planted trees and shrubs across the mitigation site was 90 percent (total count). Mowed areas were replanted in November 2007. Ninety plantings were installed including 30 *Symphoricarpos albus* (snowberry), 30 *Salix sitchensis* (Sitka willow), and 30 *Cornus sericea* (redosier dogwood).

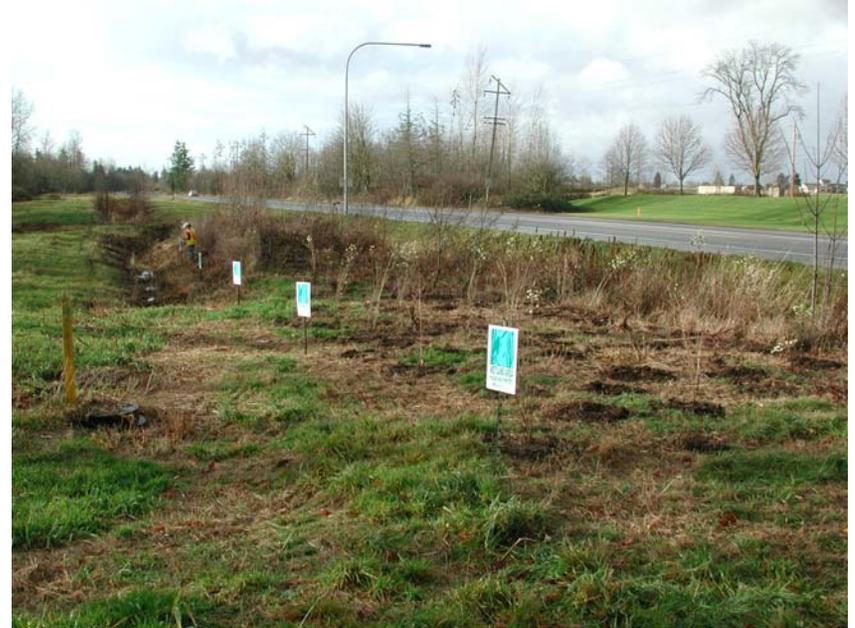
To prevent future impacts to the mitigation site, signs have been posted to clearly identify site boundaries (Photo 1).

**Photo 1**  
**Replanted area with posted signs (November 2007)**
